# Manhole Inspection Summary

Manhole # S53O\_\_053MH

Insp Date: **4/17/08 7:55 AM**

**Location** Address: **3020 elliott street**

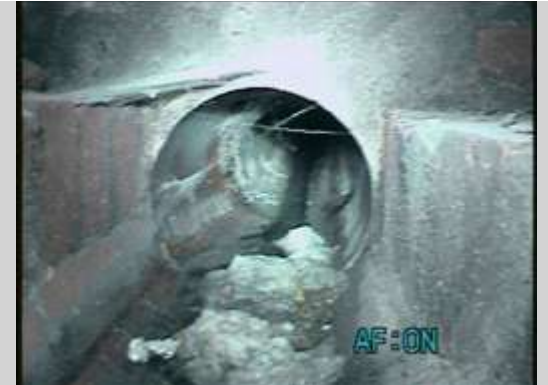
12 O'Clock Outflow

8 in. Circular Gravity Sewer  
Pipe Out @ 12 O'Clock

Pipe Material: **Clay** ☐ Pipe Lined

Invert Depth: 7.50 (ft.) Flow Characteristics: **Slow**

Deposits: ☒ None ☐ Mud ☐ Sludge ☐ Debris ☐ Grease

Infiltration: **None** Pipe Seal Cond: **Unknown**

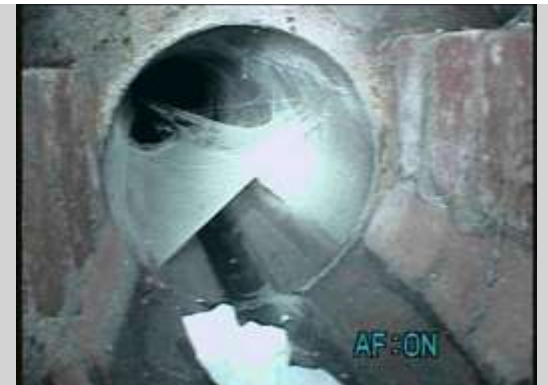
3 O'Clock Inflow

8 in. Circular Gravity Sewer  
Pipe In @ 3 O'Clock

Pipe Material: **Clay** ☐ Pipe Lined

Invert Depth: 7.50 (ft.) Flow Characteristics: **Slow**

Deposits: ☒ None ☐ Mud ☐ Sludge ☐ Debris ☐ Grease

Infiltration: **None** Pipe Seal Cond: **Unknown**
